ASCOS trip report

Summer 2008

Paul E. Johnston

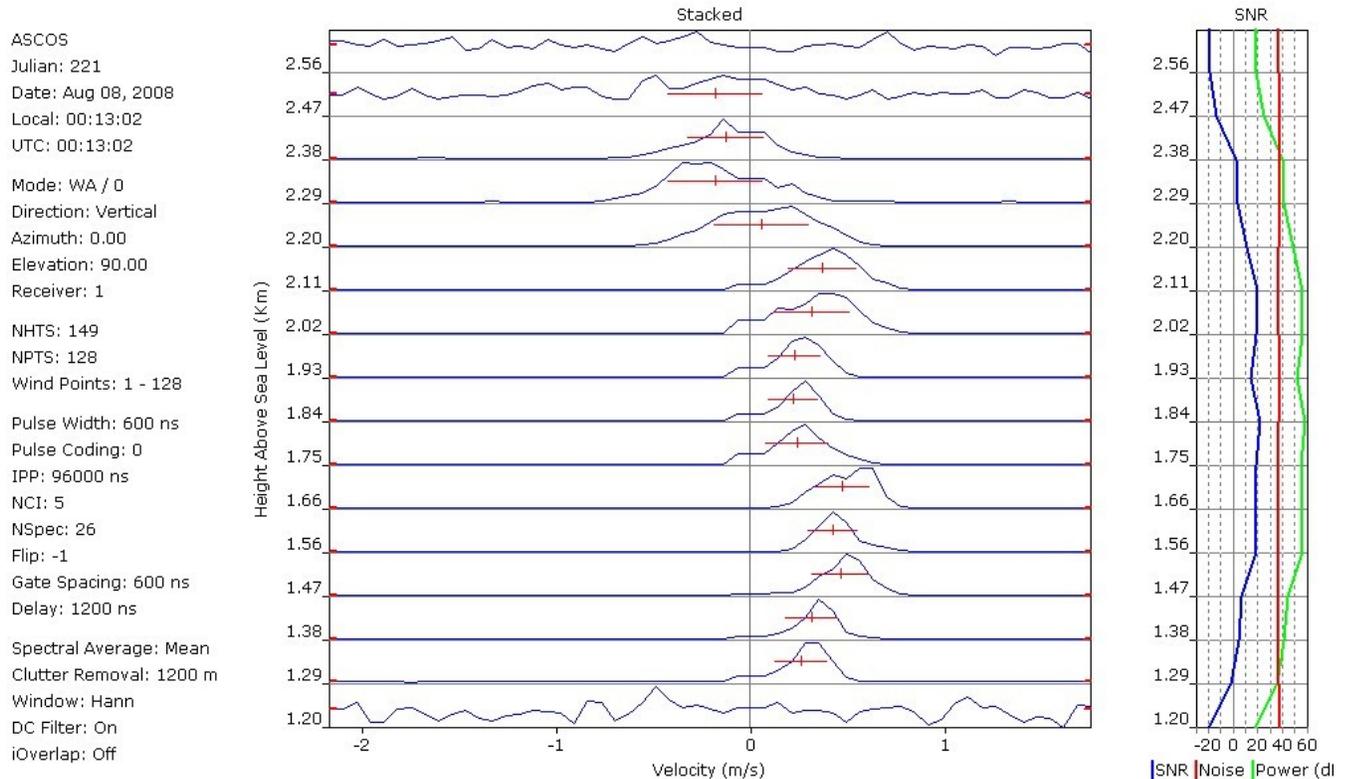
3. I note that on the MMCR the DC removal algorithm has not been implemented properly. DC is also not being subtracted, and is not being interpolated correctly. It draws a straight line across zero velocity. This gives larger widths and incorrect spectra. It also adds power to the spectra, making reflectivity off a little. This is shown in Figures 1 and 2. In Figure 1, the straight line across zero has been drawn in the spectra. It is fairly clear that this is not interpolated, but drawn straight across. The DC point is not zero, as it should be with DC removal on. In Figure 2, the straight edge of the contour is an artifact. In some cases, the contour should not cross the DC point.

Figure 1. Stacked spectra plot from D08221a.spc. DC interpolation problem is evident.

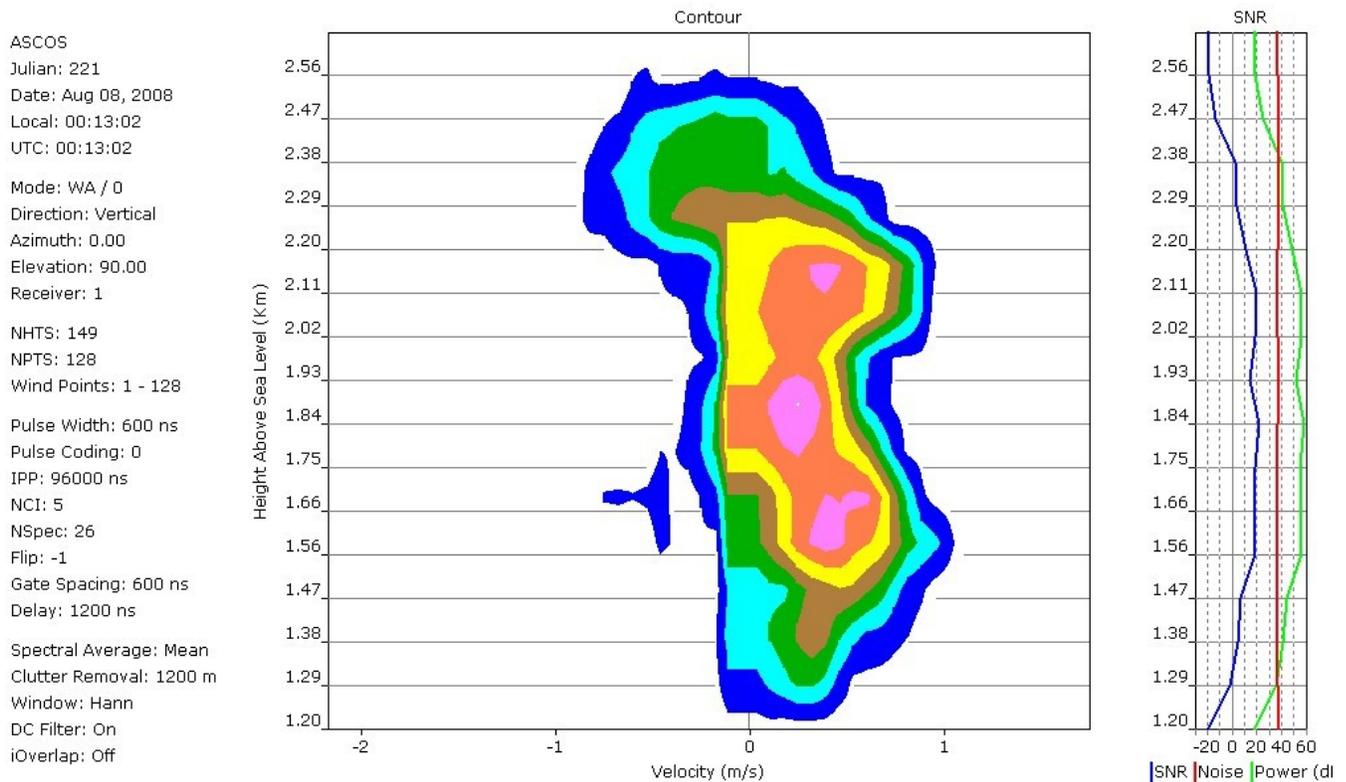
Figure 2. Contour plot of spectra from D08221a.spc. The DC interpolation problem causes the straight edge at the left side of the contours.

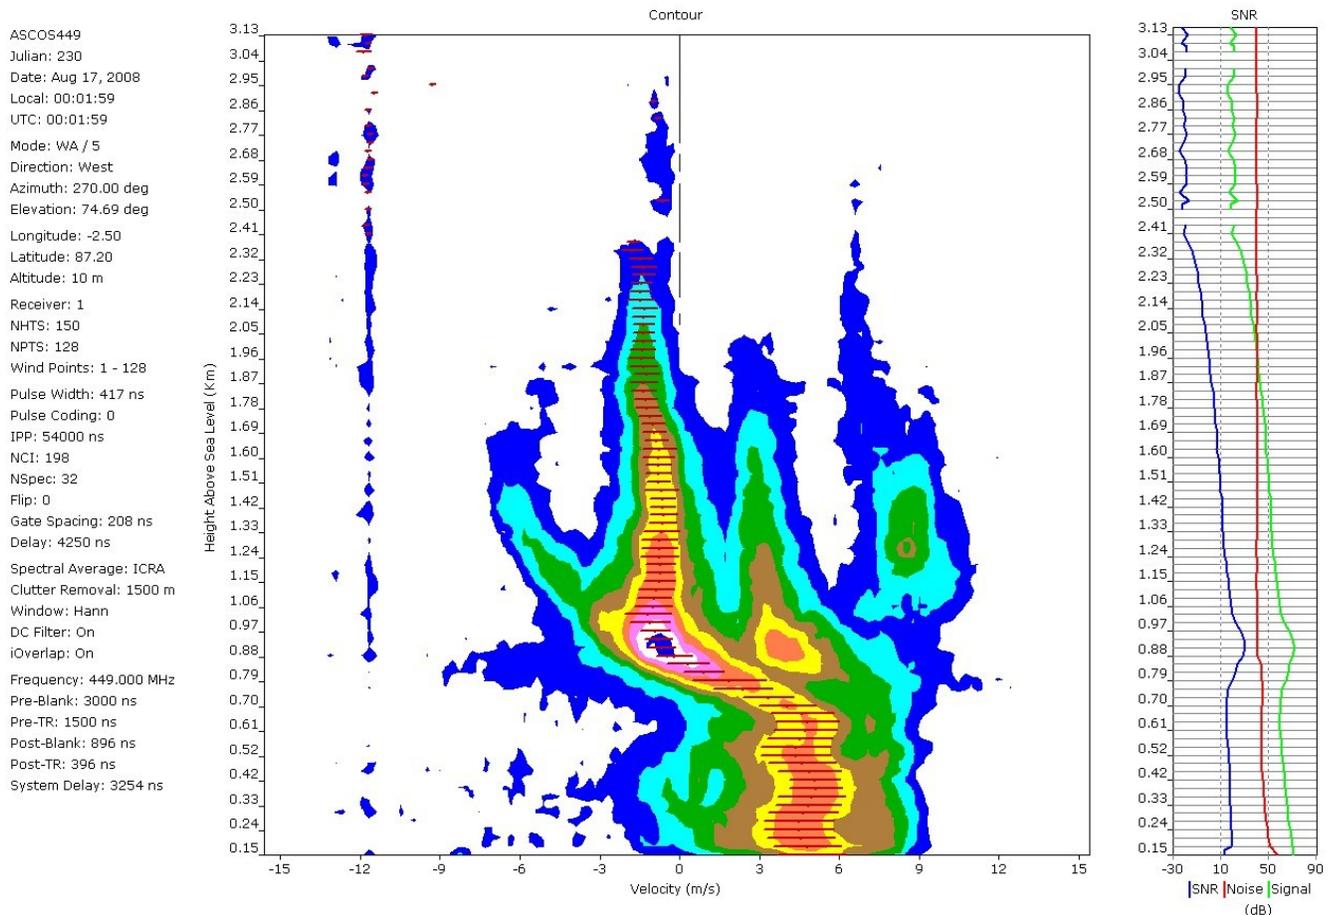
5. About 1500, I turned the 449 off for a short while to inspect the antenna. The west beam has a bad sidelobe issue. I checked the antennas to make sure they are all in the same direction. As best I can see, they are. There is a minor question whether the antennas from

different batches use the same direction notation. Figure 4 shows an example of the sidelobes. The multiple peaks are from different sidelobes. I have tried the east beam, and it also has the sidelobes. The sidelobe appears to be in the East/west plane, parallel to the big wall of the superstructure of the Oden. It appears to only be down 10 dB over the two-way radar path. When the echo comes from clear-air, only the first sidelobe appears. If the velocities are carefully examined, the sidelobe is found to not be symmetrical about the vertical. Over the course of installation and initial testing of the radar, we checked and double checked the connections and setup of the antenna. We eventually gave up and left the antenna in this state.

Figure 4. Contour plot from 449 wind-profiler showing returns from multiple antenna sidelobes. The lowest contour is 2 dB above the noise. The contour increment is 5 dB.

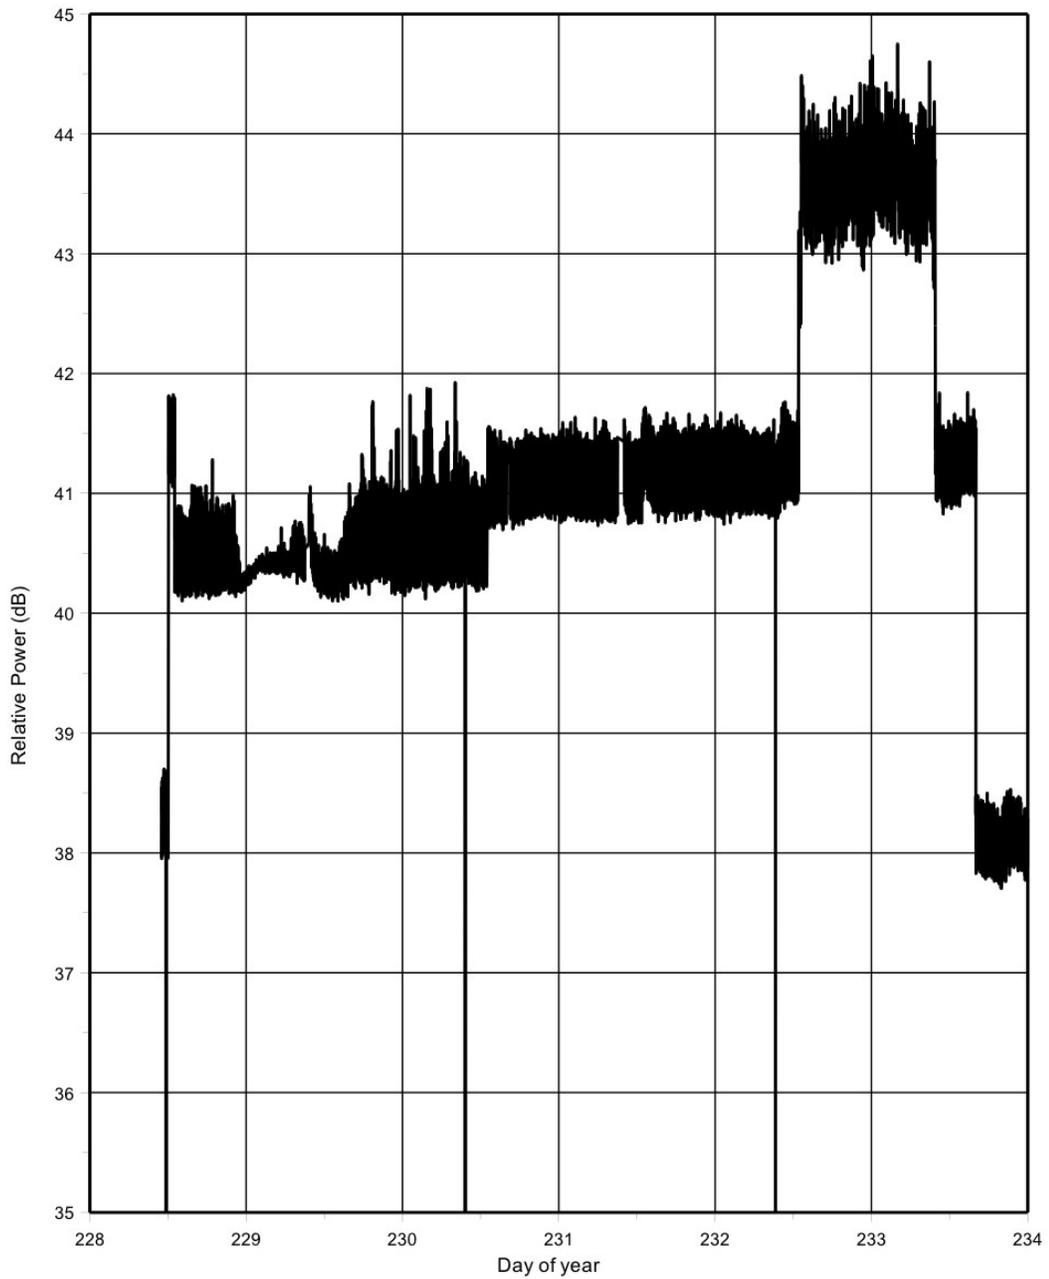
1. All systems show no errors at the start of the day.
 2. MWR pitch and roll are 0.0, MMCT pitch is 0.31, roll is 0.19.
 3. I looked at the noise (using my routine pdanoiseavNREL) on part of day 233 on the 449. It looks like the interference was causing a 2 dB increase in the the noise level. This would reduce sensitivity. Figure 5 shows the noise level, recalculated from the spectra by a program I have written for noise studies. The enhancement during 233 is very easy to spot. The drop at the end of the plot was caused by changing the number of spectral points from 128 to 256, and should be expected. The bad period of interference during days 232 and 233 showed enhanced noise of more than 2 dB. This corresponds to a degraded Signal-to-Noise Ratio (SNR) of 2 dB. I don't know the source of this interference, but changing the cable routing suggests that it was internal to our equipment. This should be examined and some work done to reduce the interference, if at all possible.

Figure 5. Average noise levels for the low mode of the 449 radar.

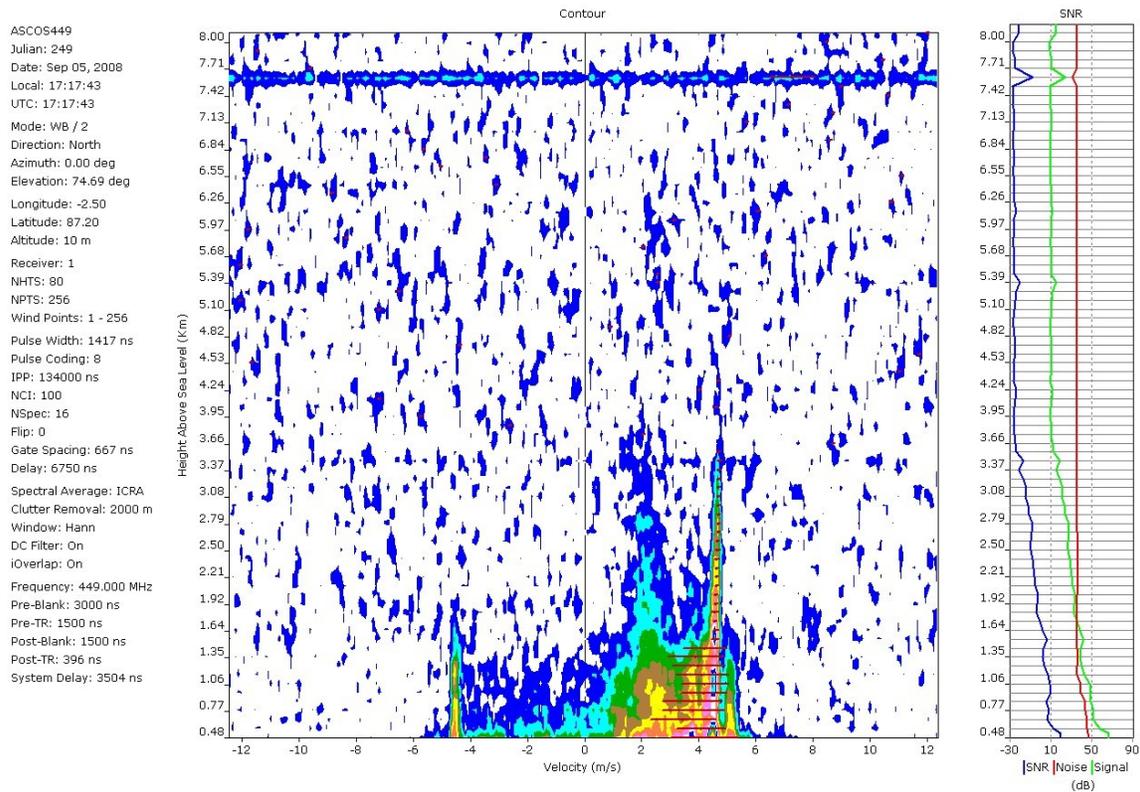
4. I spent some time looking at the 449 spectra from day 249 17:15:27 mentioned above. It turns out that the next record (17:17:43) has an even more obvious problem with the noise. Looking in detail at both records, I can see that the problem is an error in the noise level determination. This problem should be fixed, since it can lead to incorrect moments calculations, as well as ugly plots. Figures 6 and 7 show the details of this problem. Figure 6 shows how it is typically seen. In Figure 7, the low noise level in the 7.61 km spectral display is evident. This leads to enhanced SNR for this height that is not real. This is a known problem, and will be fixed in the next version of Lapxm.

Figure 6. An example of poor noise determination. The stripe near 7.5 km is not a real signal.

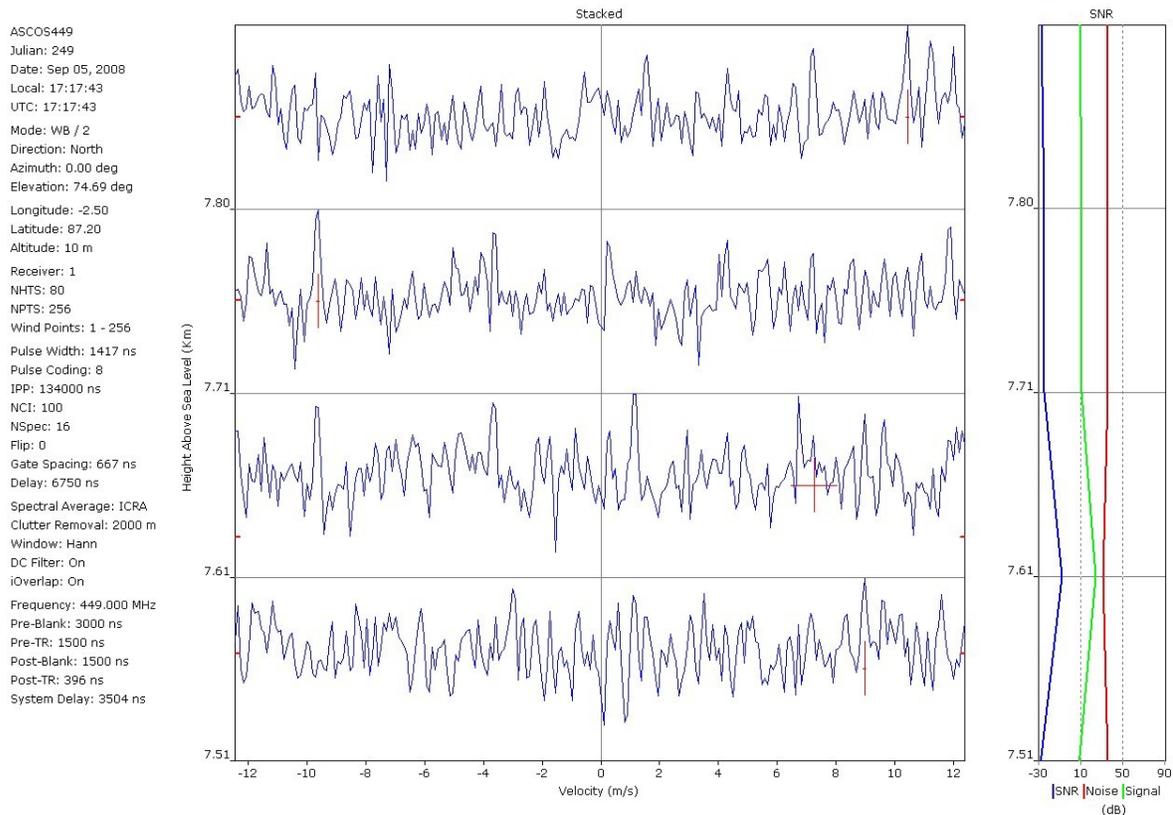
Figure 7. Details of the stripe shown in Figure 6. In the spectra of 7.61 km, the noise level has been determined at too low a level.

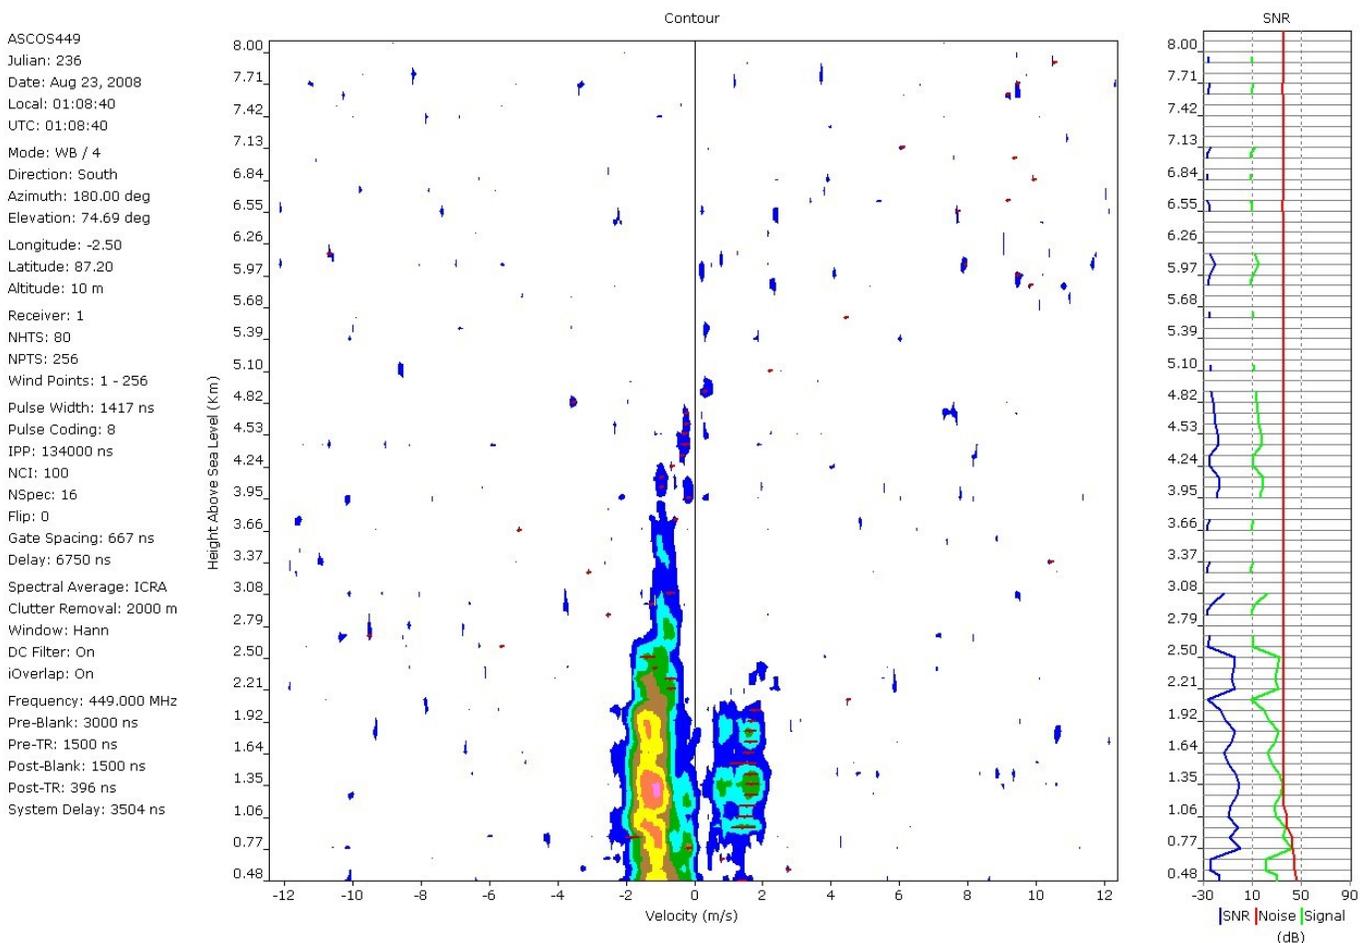
The first example is of a south beam. Here the atmospheric echo is obvious, but MPP has gone off and selected the clutter. I don't understand why this happens, but I would hope that the MPP

Figure 8.
algorithm would discriminate against clutter, not select it.

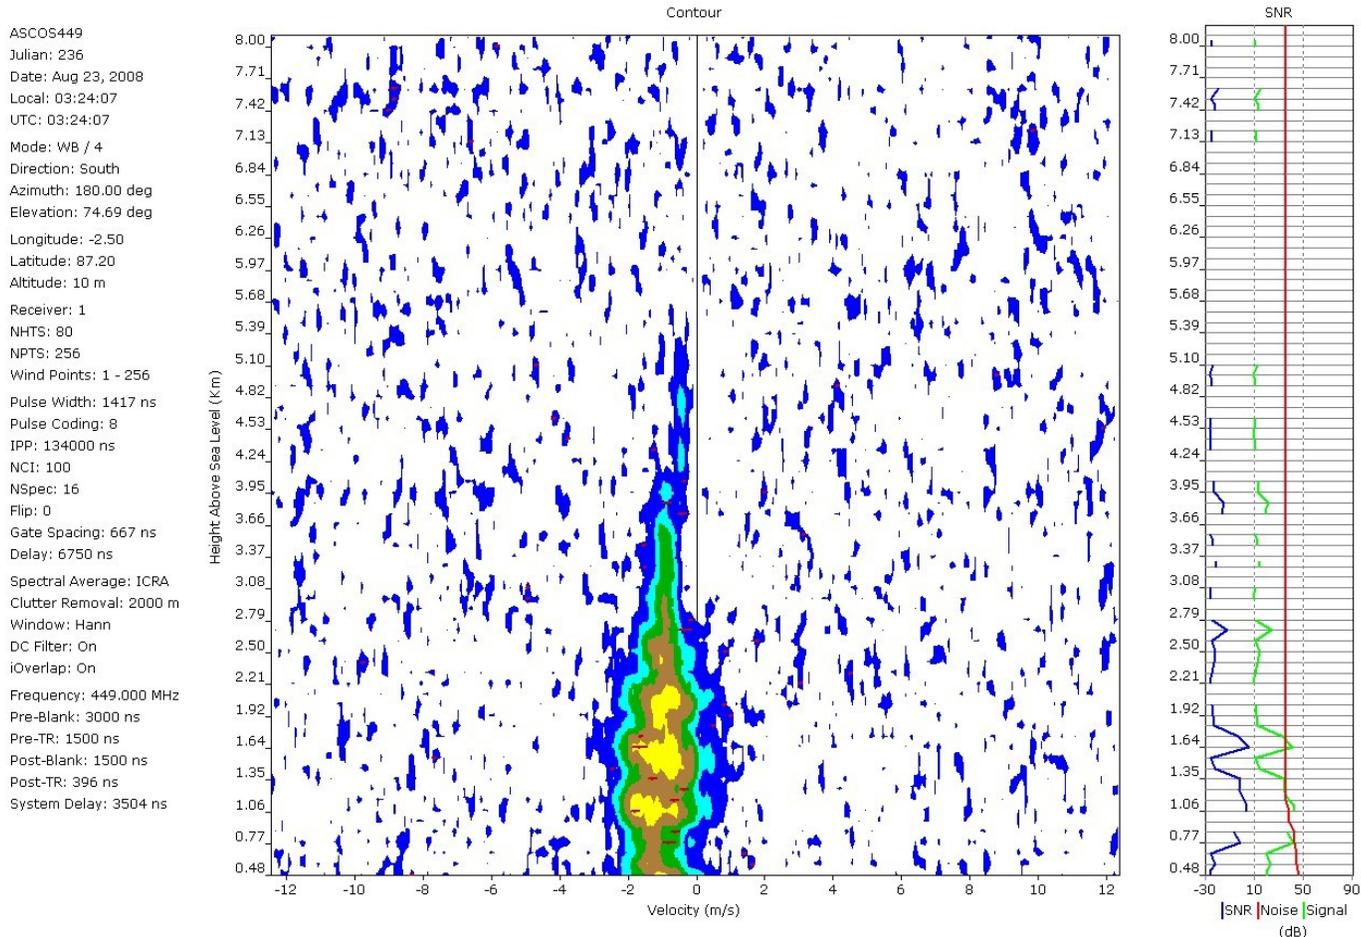
Figure 9.

The second example shows more detail. The first plot shows the contour plot of the MPP contour data. In this plot, the first contour is 1 dB above the mean noise floor. Each contour shows a 5 dB increment in power. In this case, there is little or no interference or clutter, yet the MPP moments are not placed in the atmospheric echo.

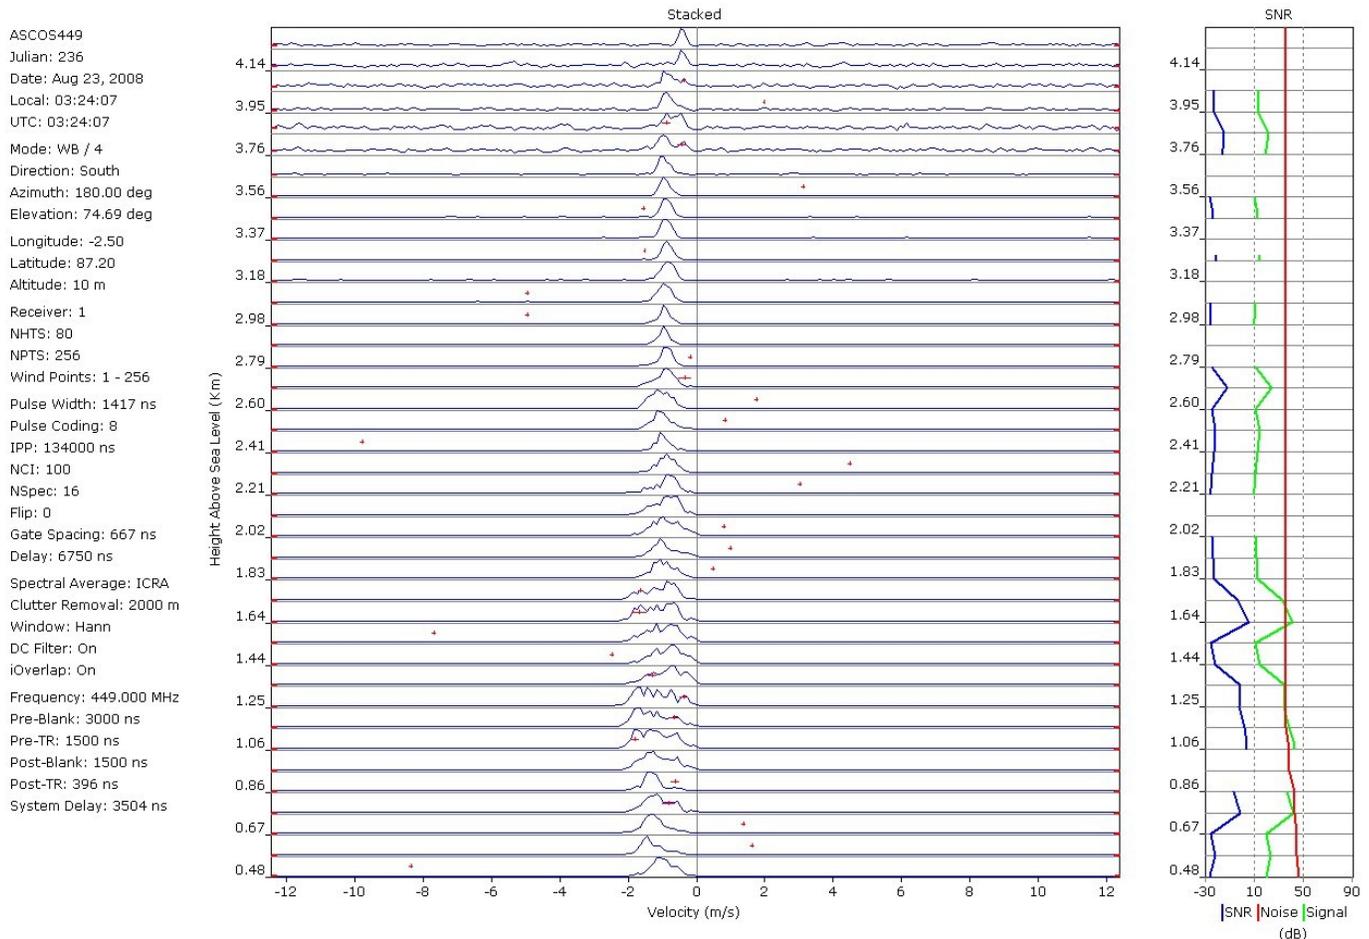
Figure 10.

In the second plot, Figure YY, MPP data is presented in the stacked plot mode, showing the lowest 40 heights. This is the same data presented in the contour plot, Figure XX. In both presentations of the data, at each height there is a red cross showing the calculated radial velocity and spectral width. In Figures XX and YY, the moments are scattered all over the velocity space.
